Experimental and analytical investigation of dynamic crack patterns in automotive windshield sheets subjected to low velocity impact

Abstract

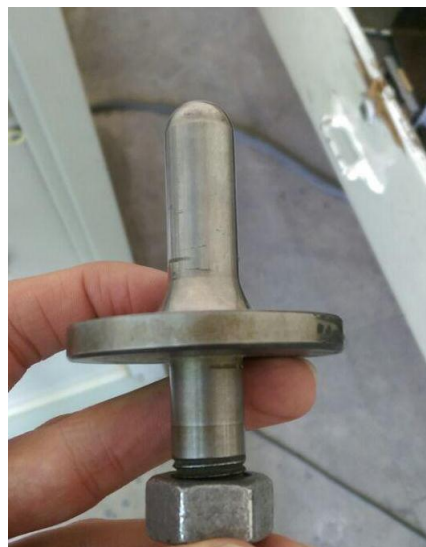
Fig2. Steel imp actor used in drop ball tests

The geometrical and mechanical properties of the impactor (which is depicted in Fig.2) are explained in Table 2.

Table 2. Properties of the imp actor

Geometrical properties	Mechanical properties
Spherical part: Diameter= 16mm	Material: steel
Cylindrical part: Height 45mm	$E= 200\text{GPa}$, $\mu=0.3$

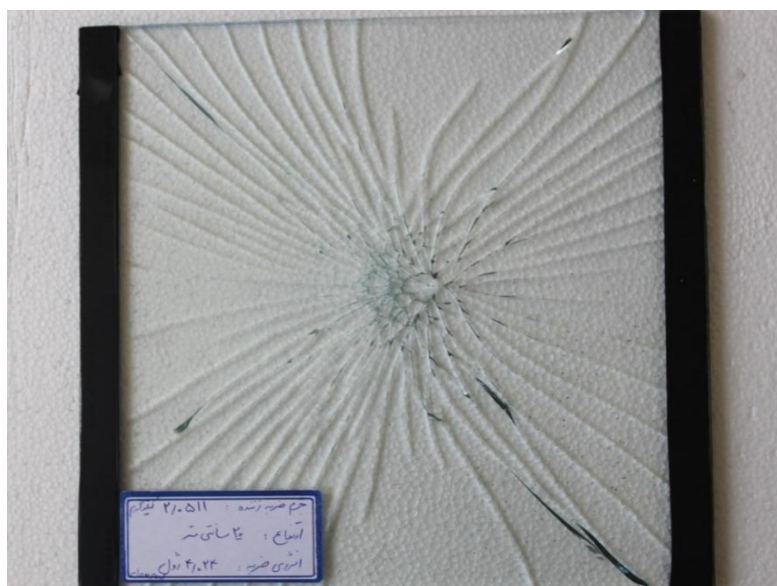
Fig6..specimen after test code D-B-T-2

Laminated glass specimen after test code D-B-T-2 is shown in Fig.6

Like test code D-B-T-1, no circumferential crack is observed at the specimen. The results of this test are akin to the test code D-B-T-1, just 2 differences are observed:

There are 62 radial cracks which is five number less than test code D-B-T-1.

The damage region at the center of specimen in test code D-B-T-2 is a bit larger than the counterpart region in test code D-B-T-1.

Indeed, some part of failure mode has been transformed to powdering failure mode.
