# Experimental and analytical investigation of dynamic crack patterns in automotive windshield sheets subjected to low velocity impact

Automotive Fluids and Structures Analysis Research Laboratory, School of Automotive Engineering, Iran University of Science and Technology, Tehran 16846-13114, Iran

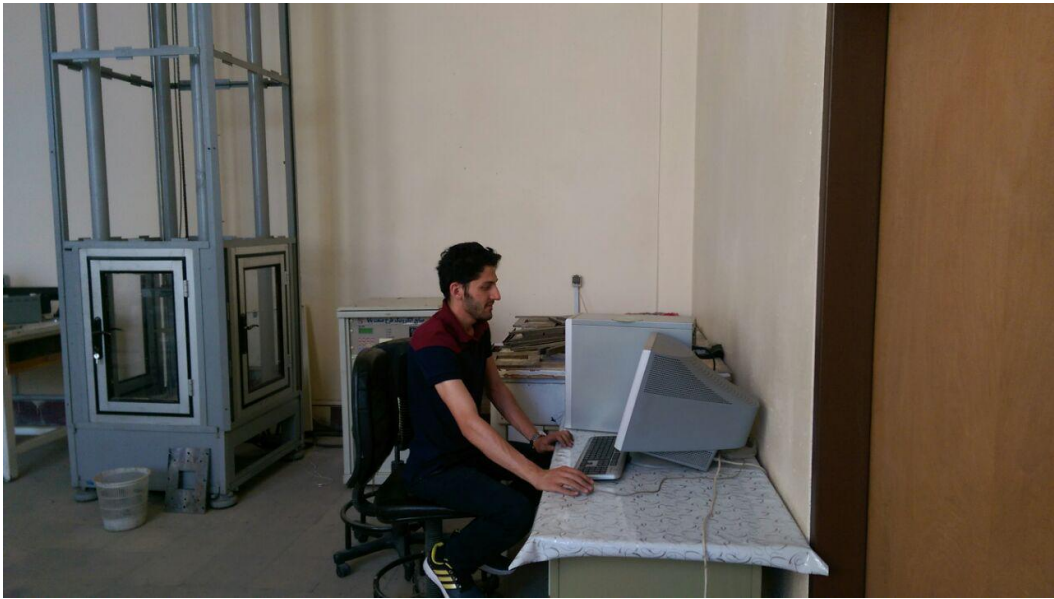
Fig1.Drop ball test machine used for experimental tests

The experiments were conducted on a drop ball testing machine (shown in Fig.1) equipped with accelerometer to investigate the laminated glass temporal response after the impact of a hard sphere. Some other specifications of the machine are shown in Table 1.

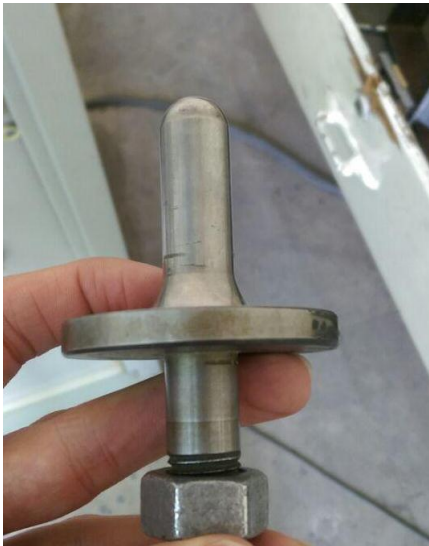
Fig2.Steel imp actor used in drop ball tests

The geometrical and mechanical properties of the impactor (which is depicted in Fig.2) are explained in Table 2.

Geometrical properties	Mechanical properties
Spherical part: Diameter= 16mm	Material: steel
Cylindrical part: Height 45mm	E= 200GPa, $\mu=0.3$
